**Canal &
River Trust**

Pontcysyllte Aqueduct Bridge Owners Forum

4th June 2024

Pontcysyllte (Pont-Cuss-Ull-Tee) Aqueduct

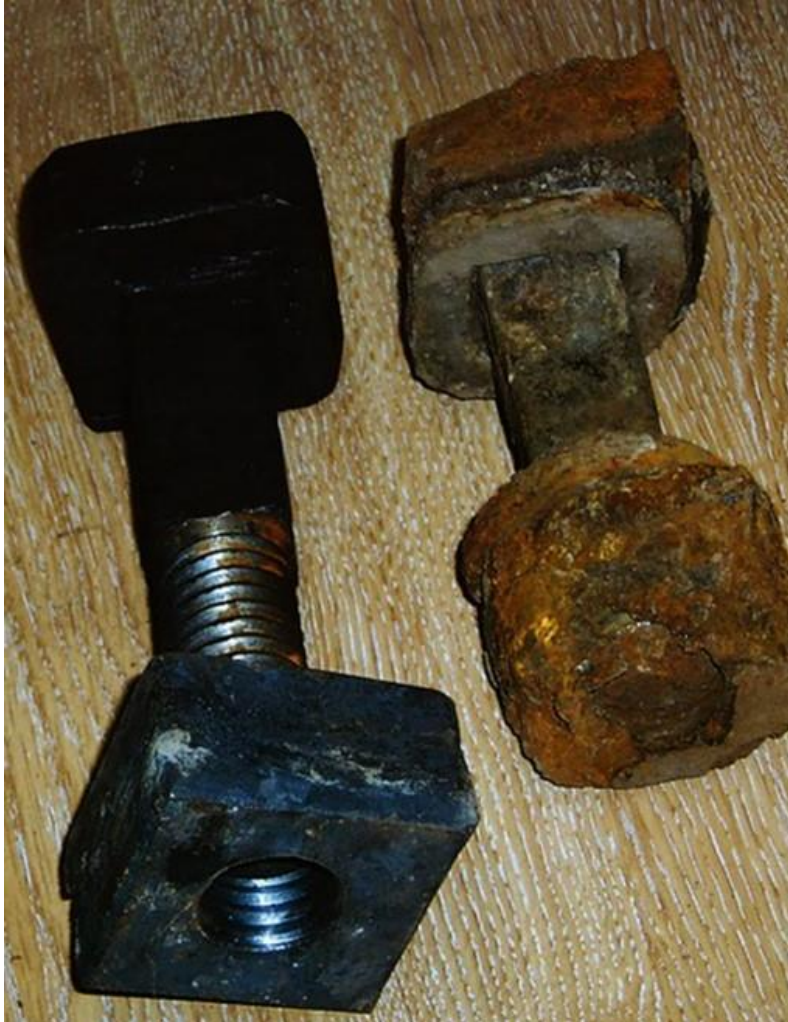
2003-4 Refurbishment – Ironwork

- There are approximately 4180 wrought iron nut and bolt connections to the trough invert plates alone.
- 750No. nut and bolt connections were found to be in poor condition and were replaced.
- The following replacement works were also undertaken:
 - 1000No. nuts;
 - 36No. bolts to rib fascia panels;
 - 11No. 40mm dia. horizontal tie-bars in 12 locations to arch rib springing plates;
 - 5No. cast iron towpath supports &
 - 22No. cast iron towpath cross members.

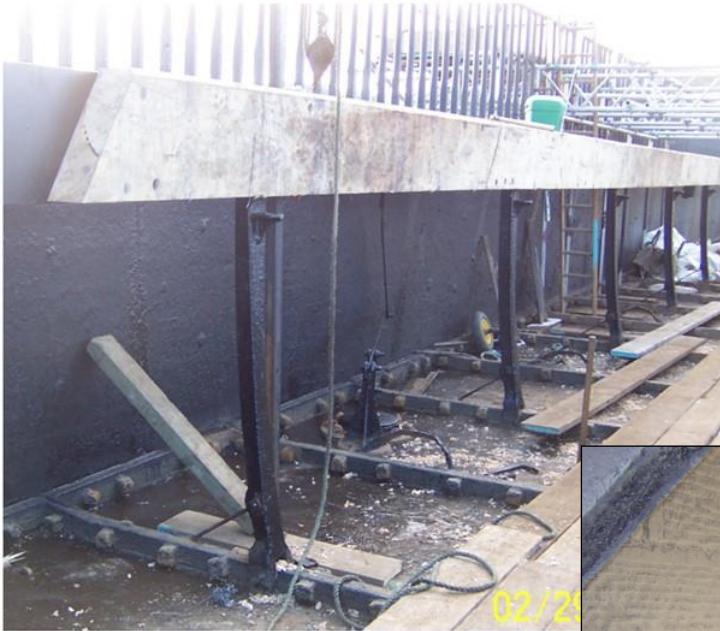
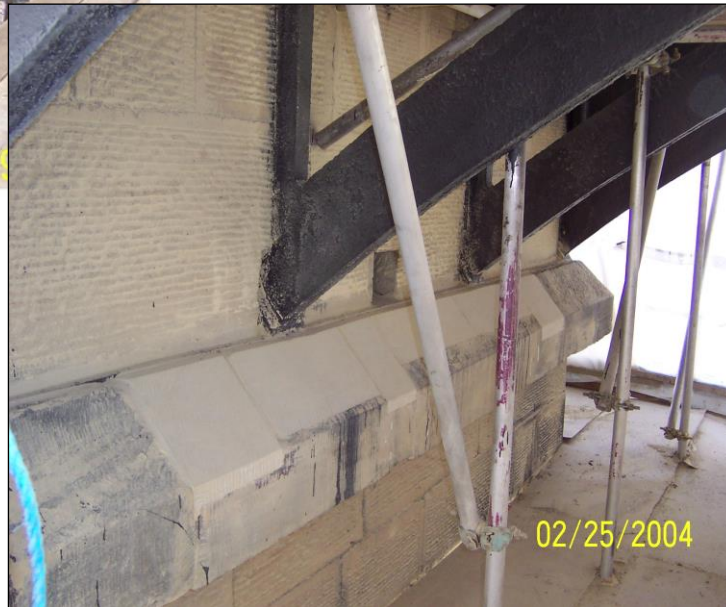
2003-4 Refurbishment – Other Works

- Other works included:
 - New towpath buckle plates;
 - Towpath resurfacing;
 - Timber fender replacement;
 - Masonry corbel repairs to piers &
 - Painting of exterior elevations
- The remaining original trough invert bolts require close inspection at next available opportunity.

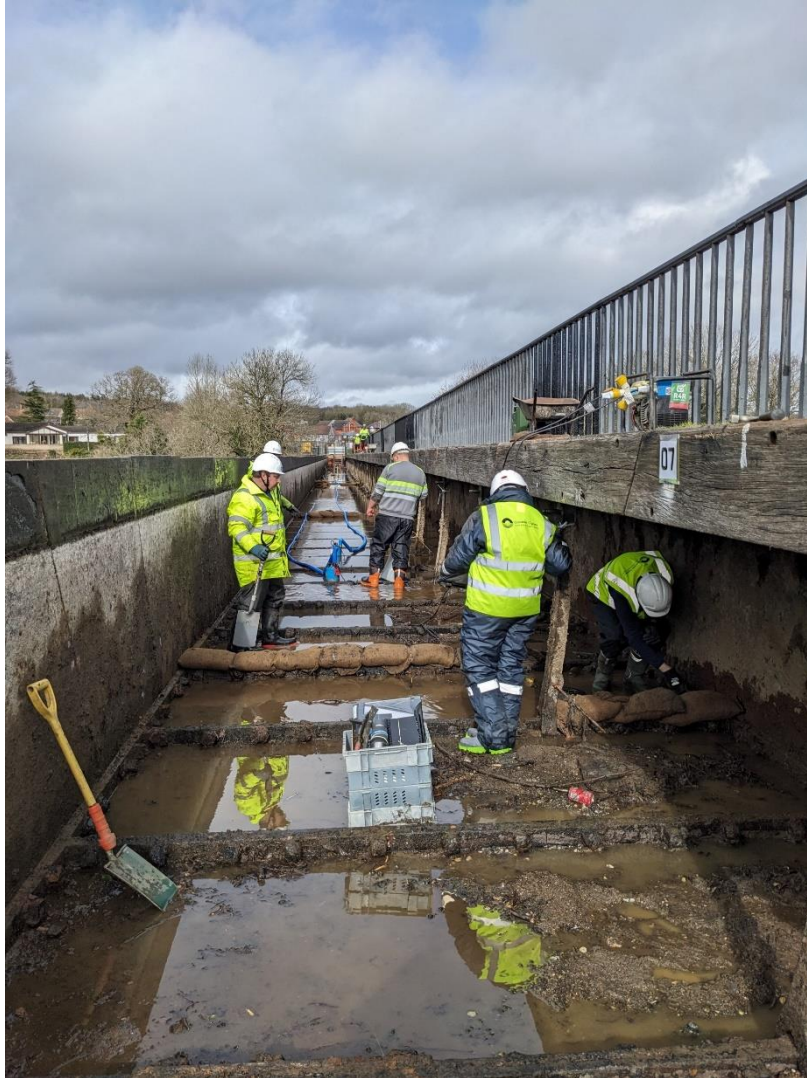
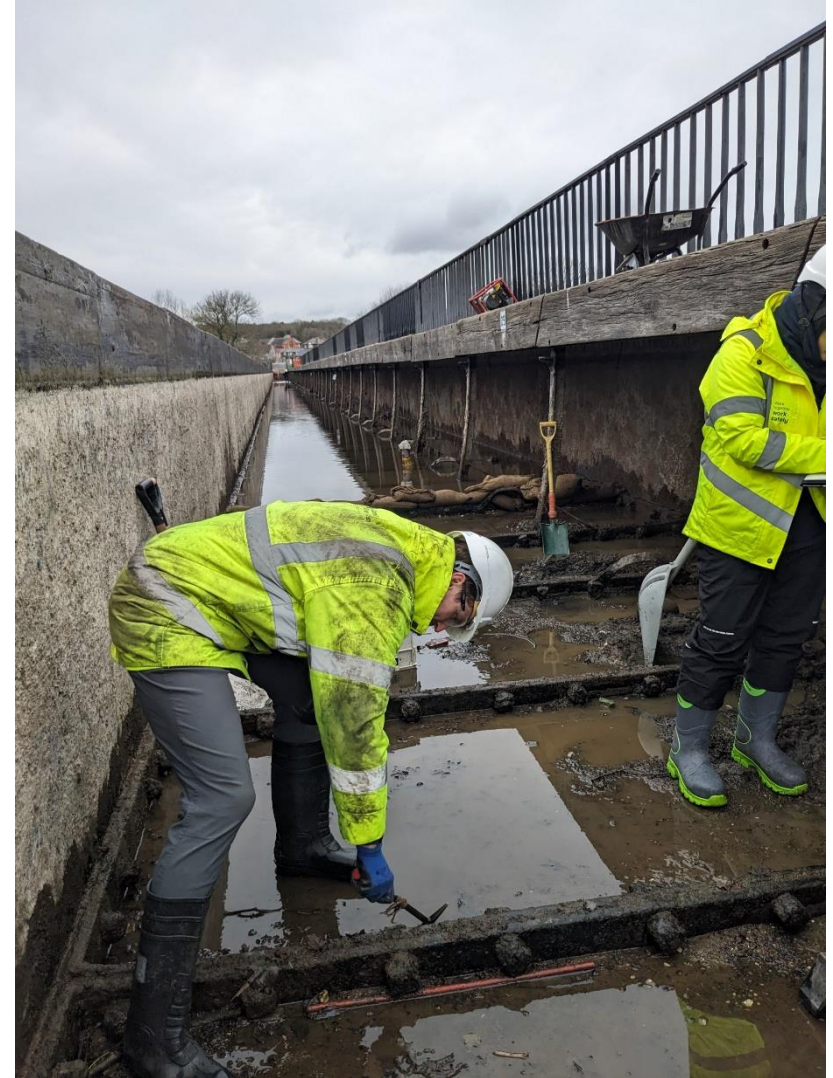
Trough clearance & bolt inspection

- 20No. diagonal stays replacement (temporary works solution installed)
- 1No. horizontal tie-bar replacement
- 5No. Nuts and bolts replacement to trough floor panels*

* Adjacent bolted connections remain in good condition.

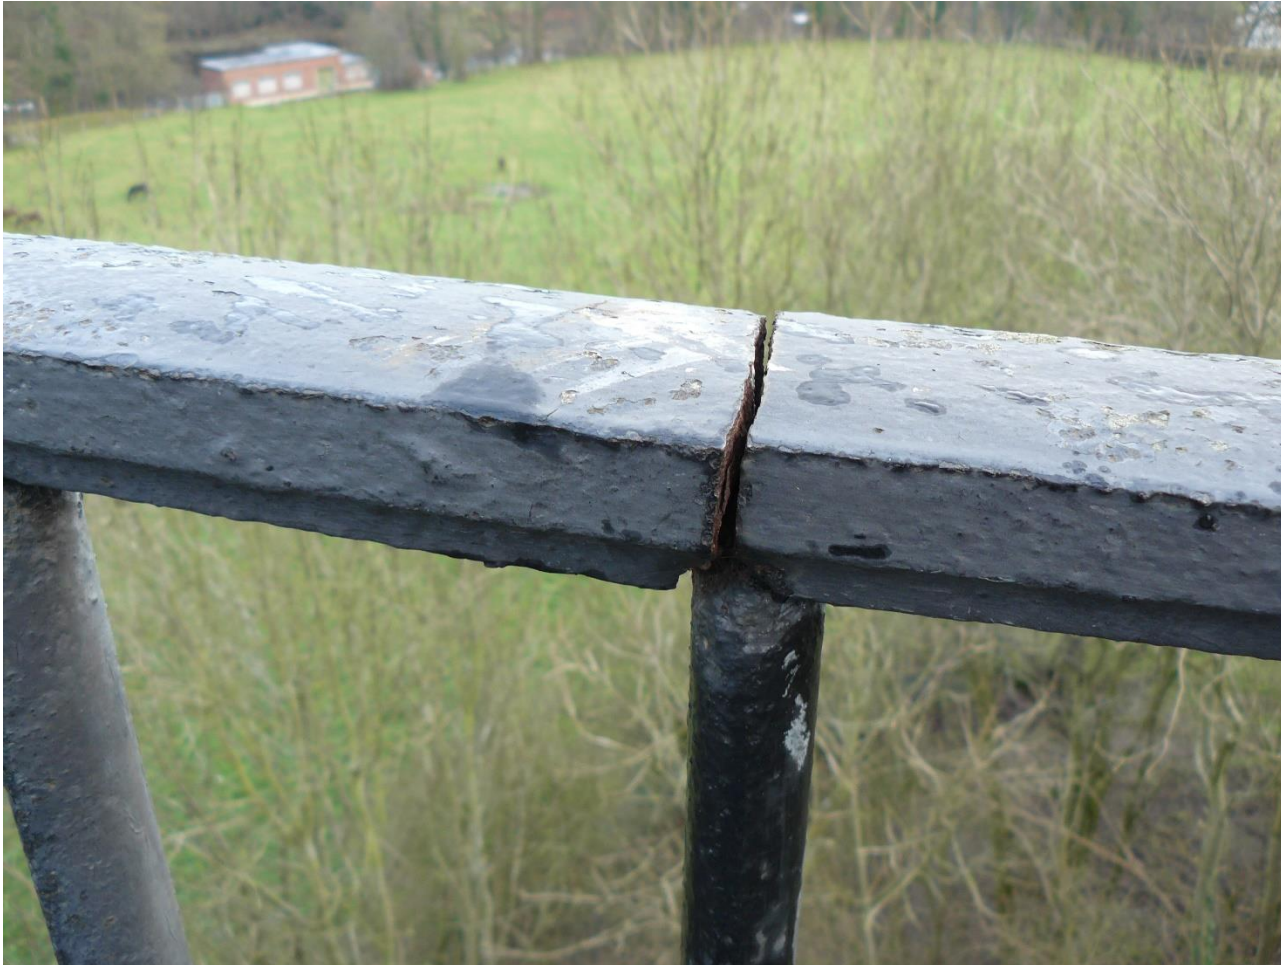
Parapet repair works

- Specialist blacksmiths were undertaking routine maintenance repairs to the parapets during the 2024 inspection.
