Preservation of our Infrastructure Heritage

Jean-Philippe FUZIER : Scientific Director Emeritus, Consultant for Freyssinet

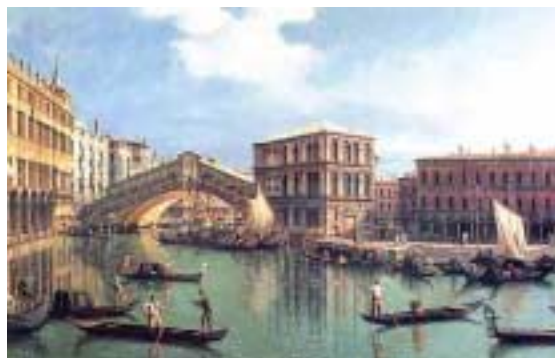
Figure 4 : the Ponte di Rialto in Venice (Italy)

The Ponte di Rialto, built between 1588 and 1591, is possibly the most famous of all inhabited bridges. Its history is closely related to that of its predecessor (a wooden bridge) on the same site and, at the time of its construction, the fervour aroused among architects and public alike was sparked not by the presence of shops along its causeway but by the fact that it had no piers.

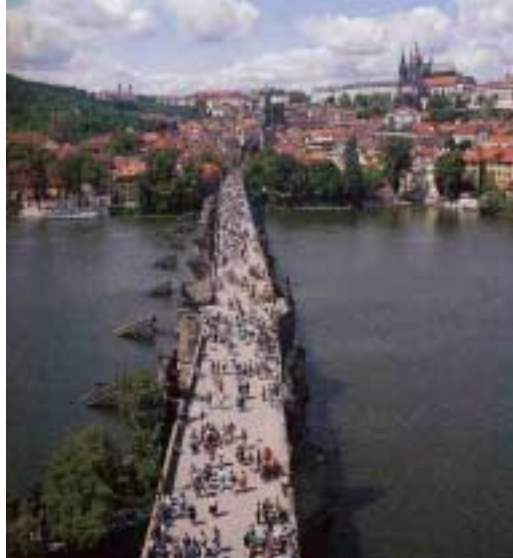
. Charles Bridge in Prague (Czech Republic)

The Charles Bridge is 516 m long and 10 m wide. It was completed at the beginning of the 15th century including the two tower gates at each end. This is today the real masterpiece and landmark of Prague.

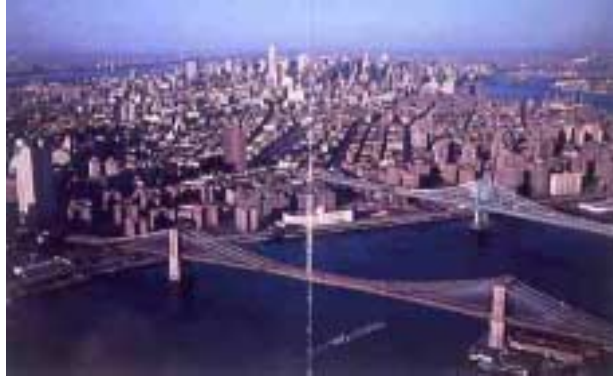
. The Brooklyn Bridge in New York

The Brooklyn Bridge in New York over East River was built in 1870-1883 and connects New York City with Brooklyn. With spans of 283 + 488 + 283 meters, it is exceptional by its relatively very long side-spans. The construction of the bridge was entrusted to J.A. Roebling and after his death in 1869, his son W.A. Roebling was chief engineer on the work which lasted from 1870 to the completion in 1883. The bridge was built with 4 main cables, each consisting of 5300 parallel galvanized steel wires. At the time of completion, the bridge represented a record with regard to span and traffic capacity. It is still in service after various changes in its suspended bridge deck.

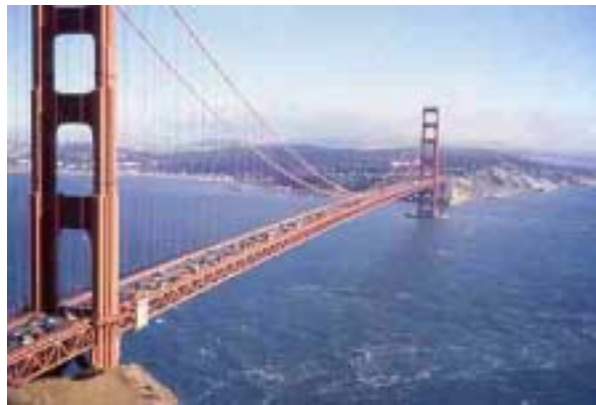
. The Golden Gate Bridge in San Francisco

The construction of the bridge was started in 1933 and completed in 1937 under the direction of J.B. Strauss. The bridge is situated in exceptionally beautiful scenery over the entrance to the San Francisco Bay.

The free height above water level is 67 meters. The bridge has 6 lanes, 18 meters wide in total, and 2 side-walks, each 3 meters wide. It was at that time the longest bridge in the world with a 1280 m long main span.

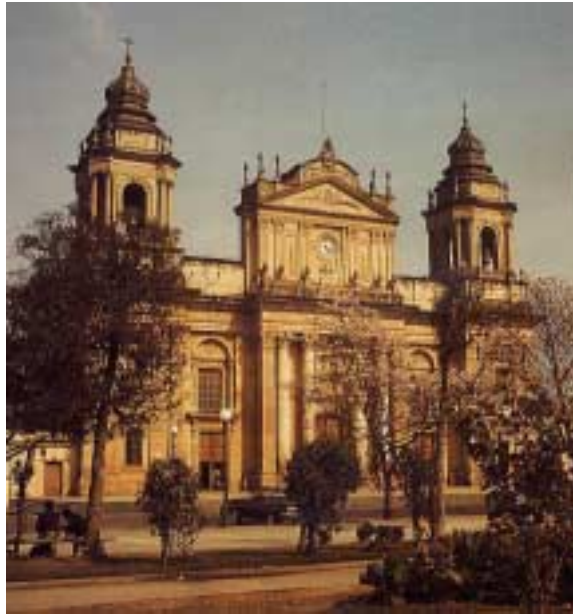
3 RESTORATION OF THE METROPOLITAN CATHEDRAL OF GUATEMALA

The Cathedral of Guatemala is a colonial style building built in about 1780 and seriously damaged by the earthquake of February 4th, 1976.

The church comprises three lengthwise naves with side chapels, a crosswise nave, a dome on the transept and façade towers. The building is 100 m long and 16 m high under the vaults. It is constructed on masonry with stone facings on the façade.

- . construction of a prestressed concrete connection beam between the towers, located above the vaults and linked by a system of prestressed concrete stringers to the body of the church going as far as the rear façade ;
- . repair of the present tower shaft masonry by a reinforced concrete skeleton, including removal and replacement of the stone facings of these towers ;
- . raising of the dome and re-building of the supports using reinforced concrete ;
- . repair of the walls, vaults and pillars inside the church.

The objective of the repair works was to respect the authenticity of the building : the cathedral should remain a gravity based structure and the vertical loads should always go down through the masonry walls allowing the transfer of horizontal loads by internal friction.

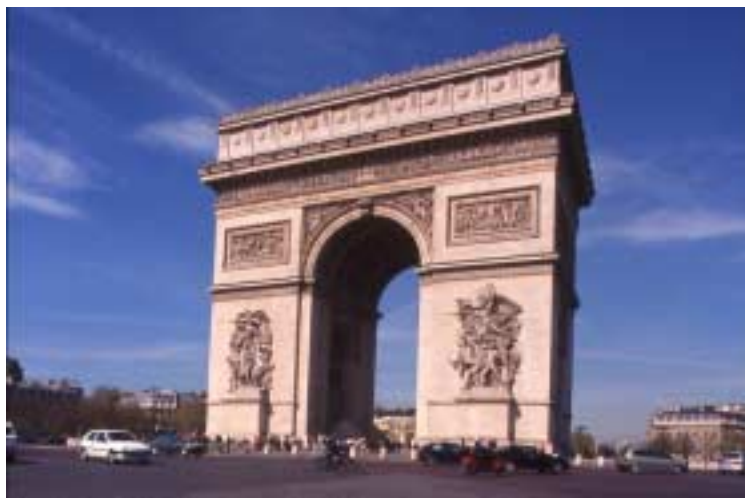
The construction of the Arc de Triomphe started in 1805. The Emperor Napoleon wanted to erect it to the glory of the Revolutionary armies which gained immortality under his command when he was only General Bonaparte. The monument was finally achieved in 1835 by King Louis-Philippe. It is 45 m long, 25 m wide and 50 m high with a total weight of 50,000 tons.

In 1983 some stones fell from the vault and the facade of the Arc de Triomphe in Paris. An investigation was then conducted followed by a series of measurements and tests to determine the origin of the phenomenon.

The analysis, which was rendered easier by existing building drawings, permitted to establish that the monument was suffering from the settlement of the foundations and a helicoidal movement of the arch.

The foundations, which consist of large stone blocks, had moved as a result of the dilapidation of the joints. The rain water coming from the Esplanade and trickling down the facades as well as the water coming from the terrace and piped through to sewers, which were probably leaking themselves, are the main causes for the underground water flow that had washed out the foundation joints and created a serious deterioration of the lime mortar.

The differential foundation settlement then brought about a “horse-saddle” deformation of the upper part of the building, that is a tendency of the pillar summits to move apart in the direction of the short sides and to converge in the other direction.

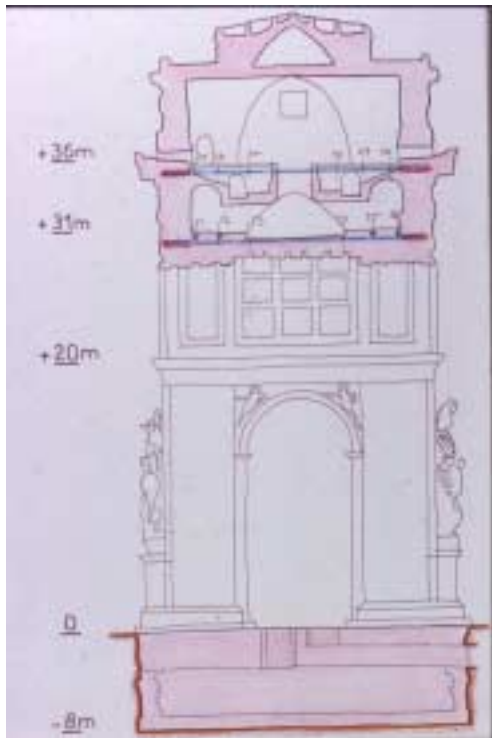
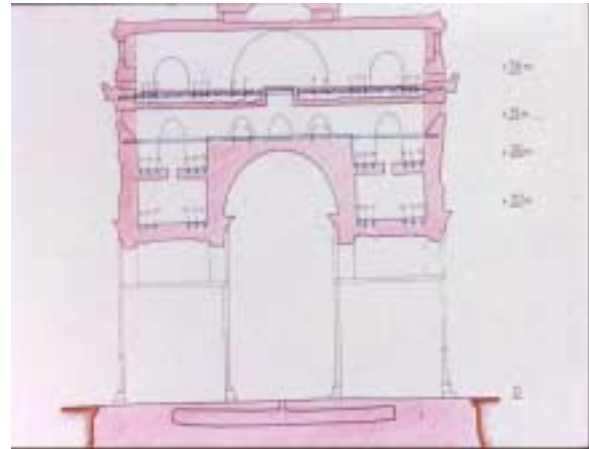
Free lengths of the ties

The external free lengths of the ties are doubly protected. The T15 strand (dia. 15,7 mm, section 150 mm²) is lodged inside a plastic sheath and protected with anticorrosive grease. This operation, carried out in the works, guarantees a self-protection of the strand right from the start.

During the assembly on site, the two strands forming a tie are threaded through a high density polyethylene duct which is itself injected with cement grout after installation of the tie. The free length of the T15 tendon is therefore doubly protected in a grease film which will allow tensioning and possible ulterior adjustments of the tensioning. The active portion, the anchorage coupler 2T15, remains accessible in a closed recess and protected by a casing injected with wax.

In the case of the Arc de Triomphe, the operation consists of additional prestressing installed inside the structure in order to compress the fractured zones and to centre hereby the oblique forces produced by the thrust of the vaults. This additional prestressing is provided by 112 half-ties anchored in the facings and connected in pairs at their centres by active couplers.

The recess, necessary for anchorage, is formed by direct rotation drilling, core drilling or down-the-hole hammer. The drilling is so done as to place anchorage as near as possible to the outerfacing, allowing hereby a margin of approximately 25 cm in order to avoid breaking through. The parameters characterising the anchorage are as follows :

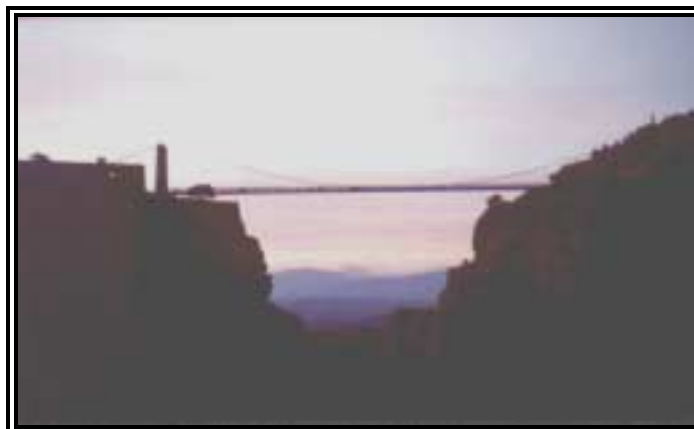
- static and dynamic tests were performed on the deck and on other members of the suspension ;
- liquid penetrating tests on steel members assembly ;
- sonic tests for the pylon masonry ;
- ultrasonic tests for anchorage heads.

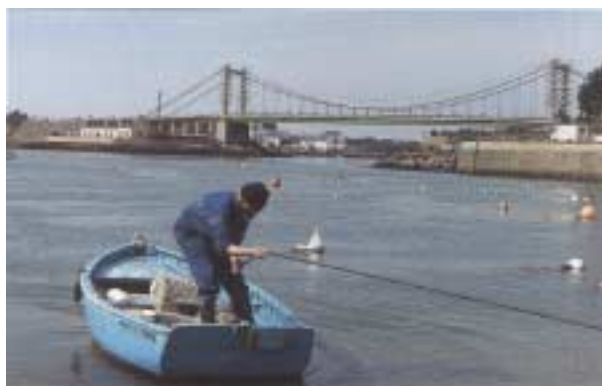
The Lorois bridge crosses the river Etel between Auray and Lorient, in southern Brittany. It is a steel suspension bridge, 237 m in length. The two main suspension cables, formed of seven cables 70 mm in dia., are anchored in massive reinforced concrete blocks on either side of the supports to the access spans. Complete replacement of these suspension cables was carried out in 1996 by FREYSSINET, on behalf of the General Council of Morbihan, without any interruption to traffic over the bridge.

Figure 5 : General view of the Lorois bridge

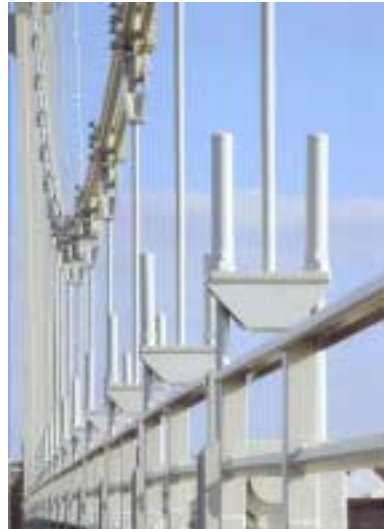
Figure 6 : the Lorois bridge : new suspension cables

Replacement of the suspension cables and hangers

- erection of scaffolding to reach the top of the pylons and construction of new bearing saddles above the existing ones ;
- installation of the new cables using a hauling winch, construction of their anchorages and adjustment of the catenary sequence they form. There are four locked coil cables, 70 mm dia., on each side, formed of parallel round wires and three layers of Z wires. All the individual wires are galvanized. The guaranteed ultimate strength of each cable is 4549 kN ;

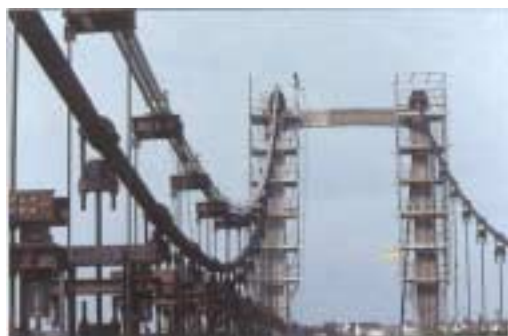
Figure 7 : the Lorois bridge : new suspension cables in place

- removal and replacement of the hangers ;
- removal of the former cables ;
- final adjustment ;
- anti-corrosion protection of the cables, hangers, collars, upper and lower fixings on the cables and the deck as well as the saddles and anchor ties.

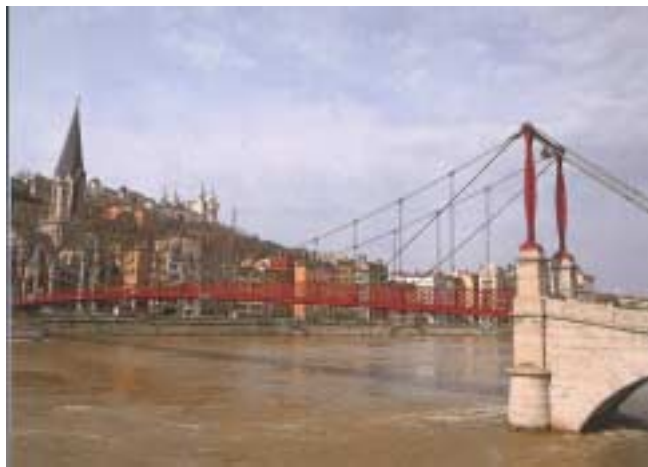
The Saint-Georges footbridge was built in 1852, bombed in 1944 and then restored and new work has recently been done on it. This work was started in summer 1998 and consisted of reinforcing the carrier tendon anchor foundations by prestressed tie rods and dismantling the deck, the former suspension and metal pylons. A new deck then had to be made combining a modern support structure and classical hand rails. It then had to be put into place and attached it to the new suspension elements.

Figure 8 : Saint-Georges footbridge : general view

The choice of dismantling and reconstruction methods had to enable continued river traffic on the Saône river. FREYSSINET worked as the main contractor and suggested innovative construction methods, including the use of two working pylons installed on the banks. These metal pylons were connected together from bank to bank by prestressing strands tensioned and stabilized by temporary stay cables anchored onto stiffeners of the anchor foundations. The deck was disassembled in 1.30 m segments and each of the forty-six elements was held in place and handled using low power pulley blocks suspended from the strands. This method eliminated the need for heavy handling equipment.

The new deck was made in three long elements. They were equipped with their handrails, delivered on a barge and very quickly put into position using a floating crane. After this phase, the two side segments, temporarily guyed to the « working pylons », supported the central segment.

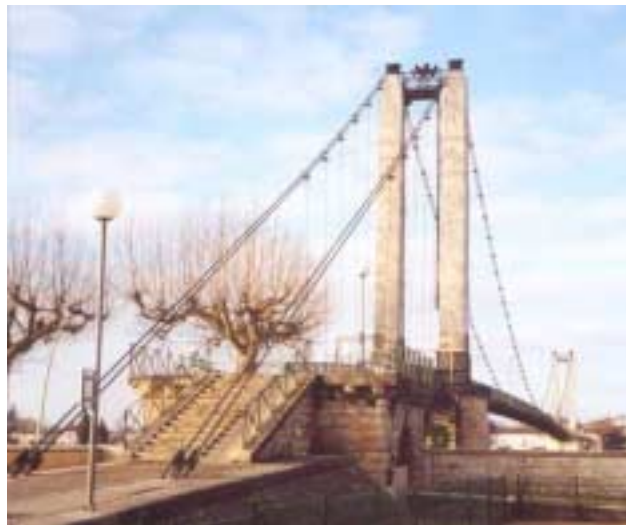
Today, the entire footbridge consists of 5 spans. The 3 suspended spans are 29,50 metres, 174,25 metres and 20,60 metres long for left side span, main span and right side span respectively. Two approach spans on the West bank consist of truss beams. The 2,80 metres wide deck consists of a steel structure covered by wooden flooring. Suspension cables rising 18 metres above the deck are supported by masonry towers equipped with saddles on rollers.

Figure 9 : the existing footbridge over the Garonne

Due to ageing of materials and structural problems encountered by the bridge, several components were replaced and pedestrian traffic has been restricted down to 15 people simultaneously on the deck.

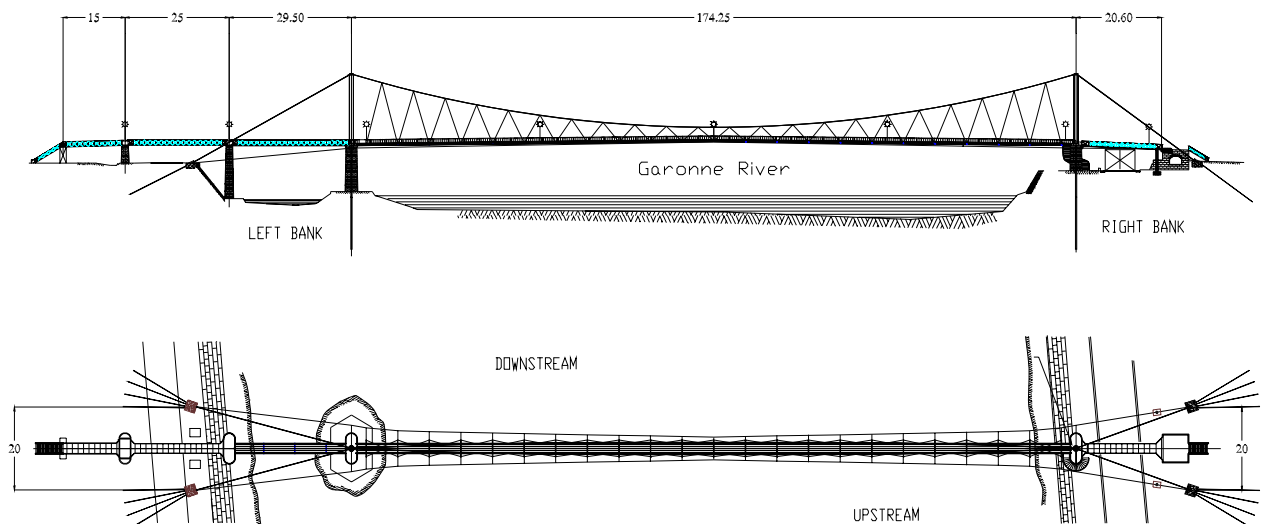
- ◆ The deck is renovated with steel I-girders and wooden flooring. Suspended side spans are replaced by simply supported truss beams.
- ◆ Masonry pylons as well as saddles on rollers are dismantled and replaced by single steel pin-connected masts supporting fixed saddles. Because of uncertainties which masonry pylons pedestals are subject to, micro-piles are used for foundations of masts.
- ◆ The suspension is renewed for the main span only and consists of two galvanised steel spiral strands supporting diagonally arranged hangers connected to crossbeams of the deck. Since ultimate tensile strength of existing ones was subject to uncertainties, new anchor blocks with bond sockets and micro-piles are provided for suspension cables.

Figure 10 : the new footbridge over the Garonne: elevation and plan

- ◆ Transverse wind-stabilising cables are added on both sides of the footbridge. These parabolic cables are connected to the deck crossbeams by means of transversal tie cables and anchored in the same blocks as the ones used for vertical suspension.
