# Bridges 2020: *Management for Long Term Performance*

23 November 2004 **Rudolph Kotze** CPEng IntPE(NZ) - Manager Structures NZTA **Cambridge**  
**September 2009**

# Risk-based Bridge Asset Management in New Zealand

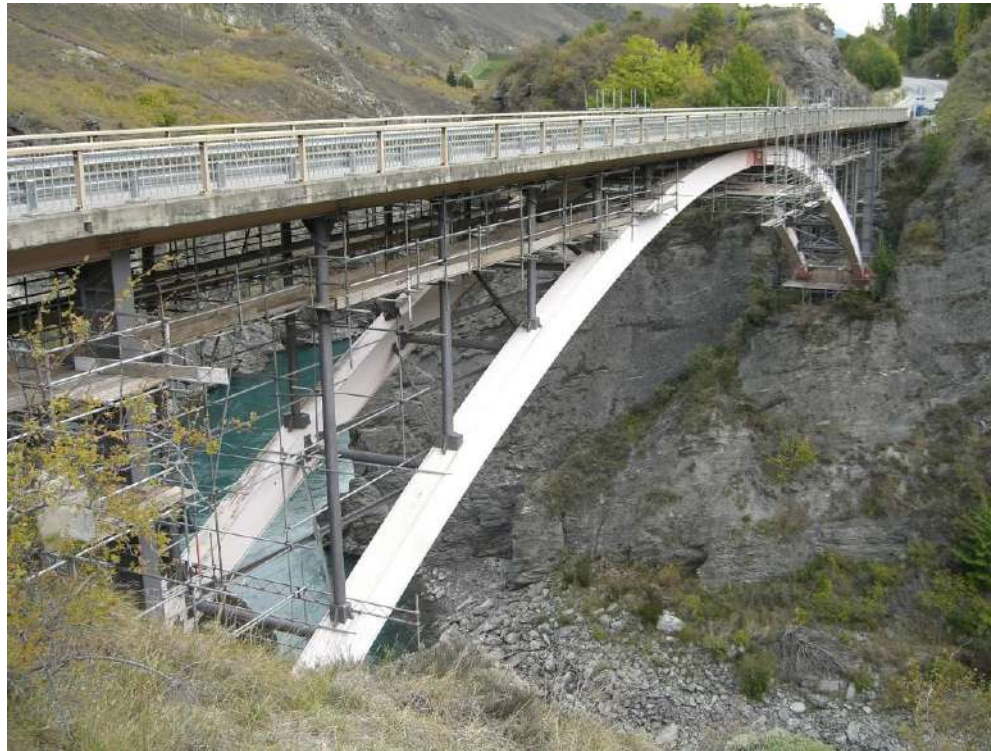
# SH6 Kawarau River Bridge

- Built 1963
- Fatigue cracks found 2008

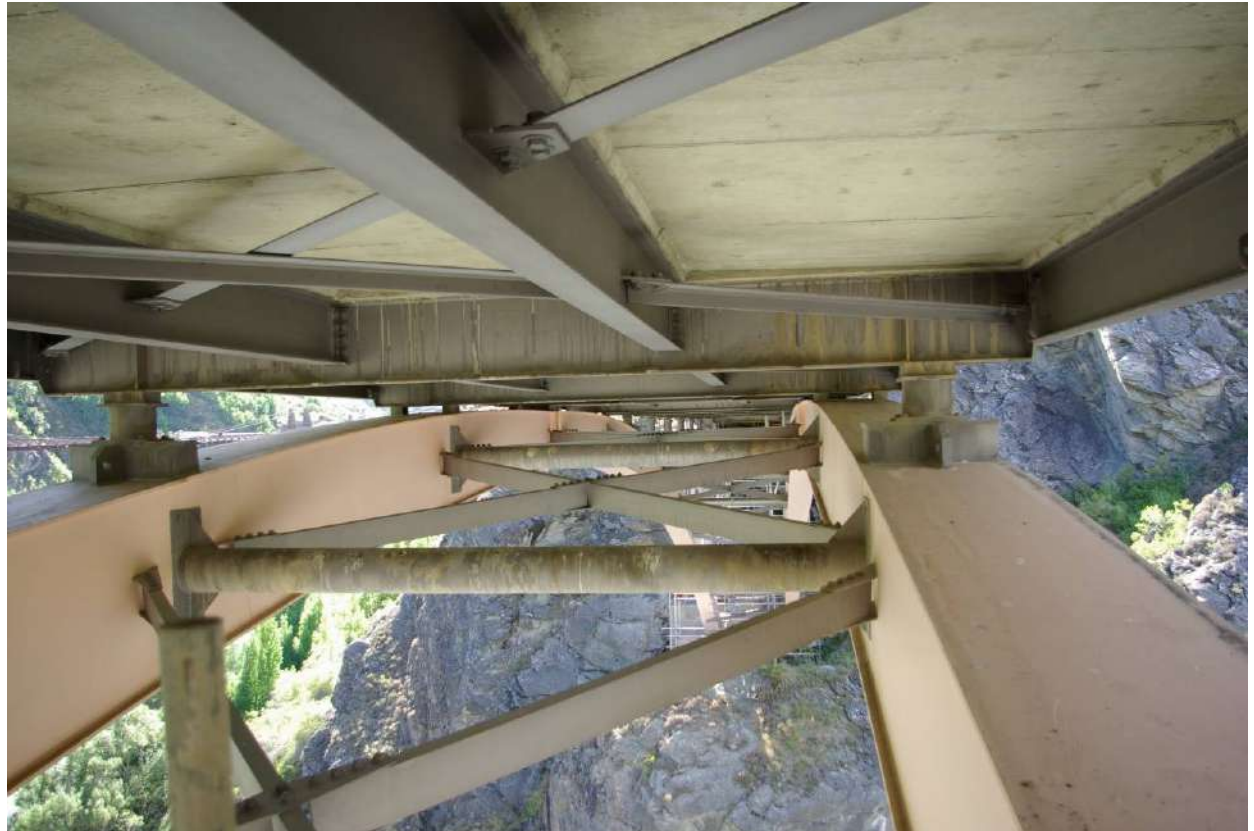
# SH6 Kawarau River Bridge

Transom  
cracks

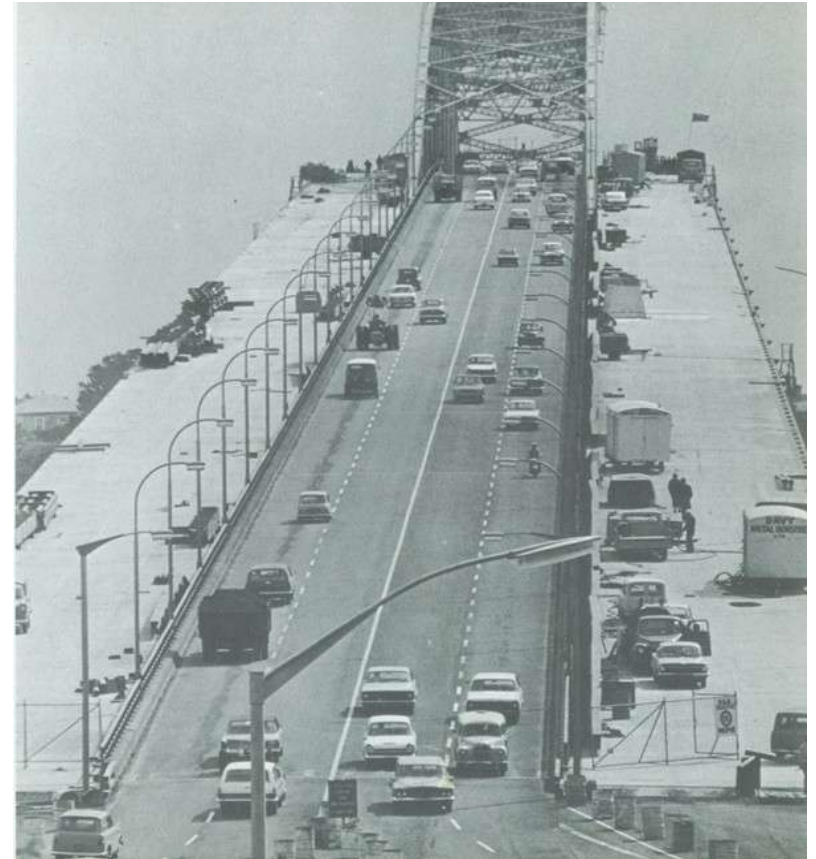
# Box Girder Extensions

Completed 1969

Early 70's box girders first strengthened

1985 - HCV's banned for 4 years -strengthened

1987 - live load upgrade

1990's - ongoing fatigue repairs

1995 – Poly-urathane road surfacing started

2000 - seismic upgrade completed

2002 onwards - traffic/structural assessments

2007 – strengthening/upgrade (live load)

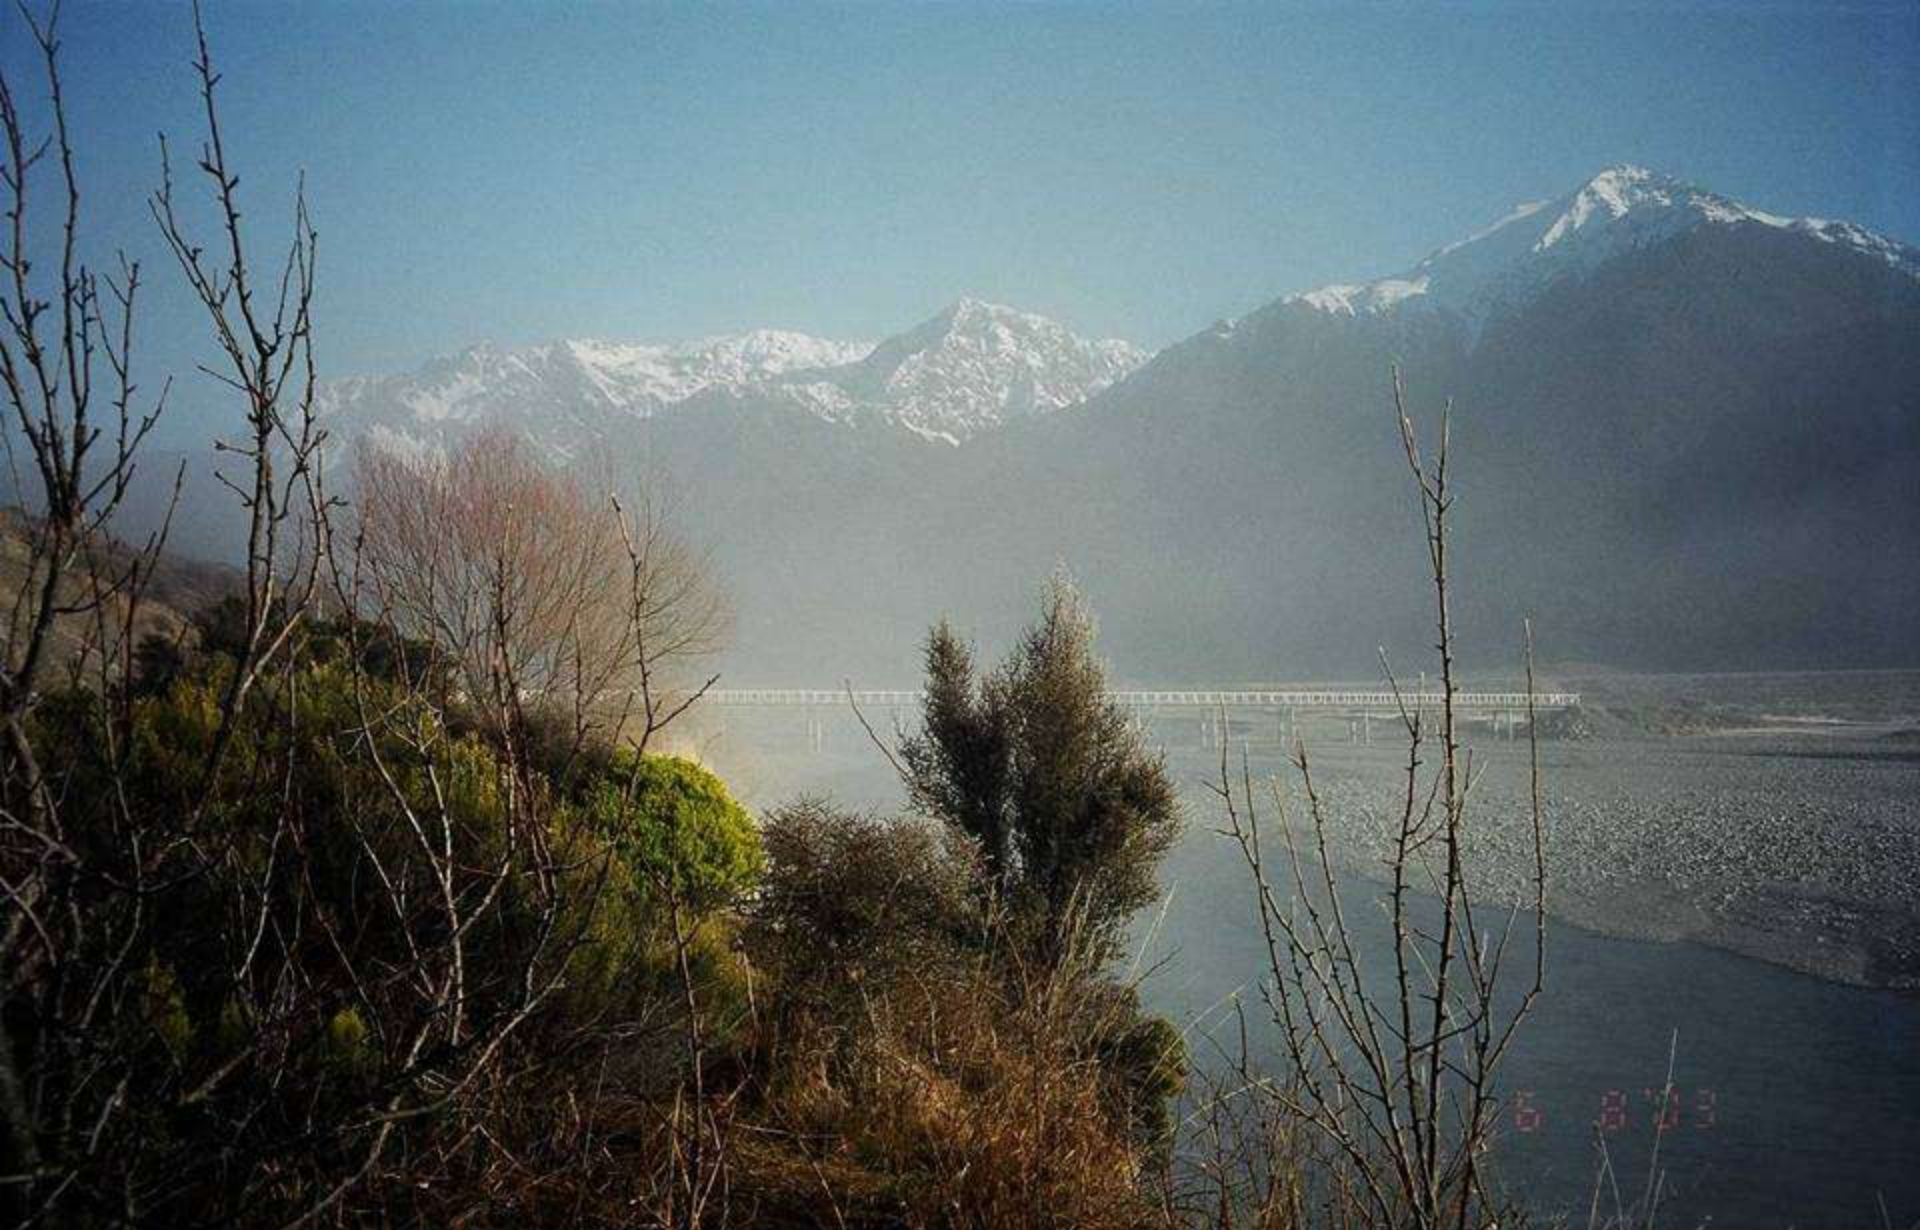
A survey of 108 bridge failures between 1961 and 1984

CAUSE OF FAILURE	NUMBER	PERCENTAGE
Approach/Abutment Scour	29	26.8
Pier Scour	34	31.5
General Scour	5	4.6
Aggradation	2	1.9
Insufficient Waterway	10	9.3
Earthquake	6	5.6
Structural Failure	14	13.0
Falsework Failure	3	2.8
Settlement	2	1.9
Landslide	3	2.8

} 74%  
1968 Inangahua

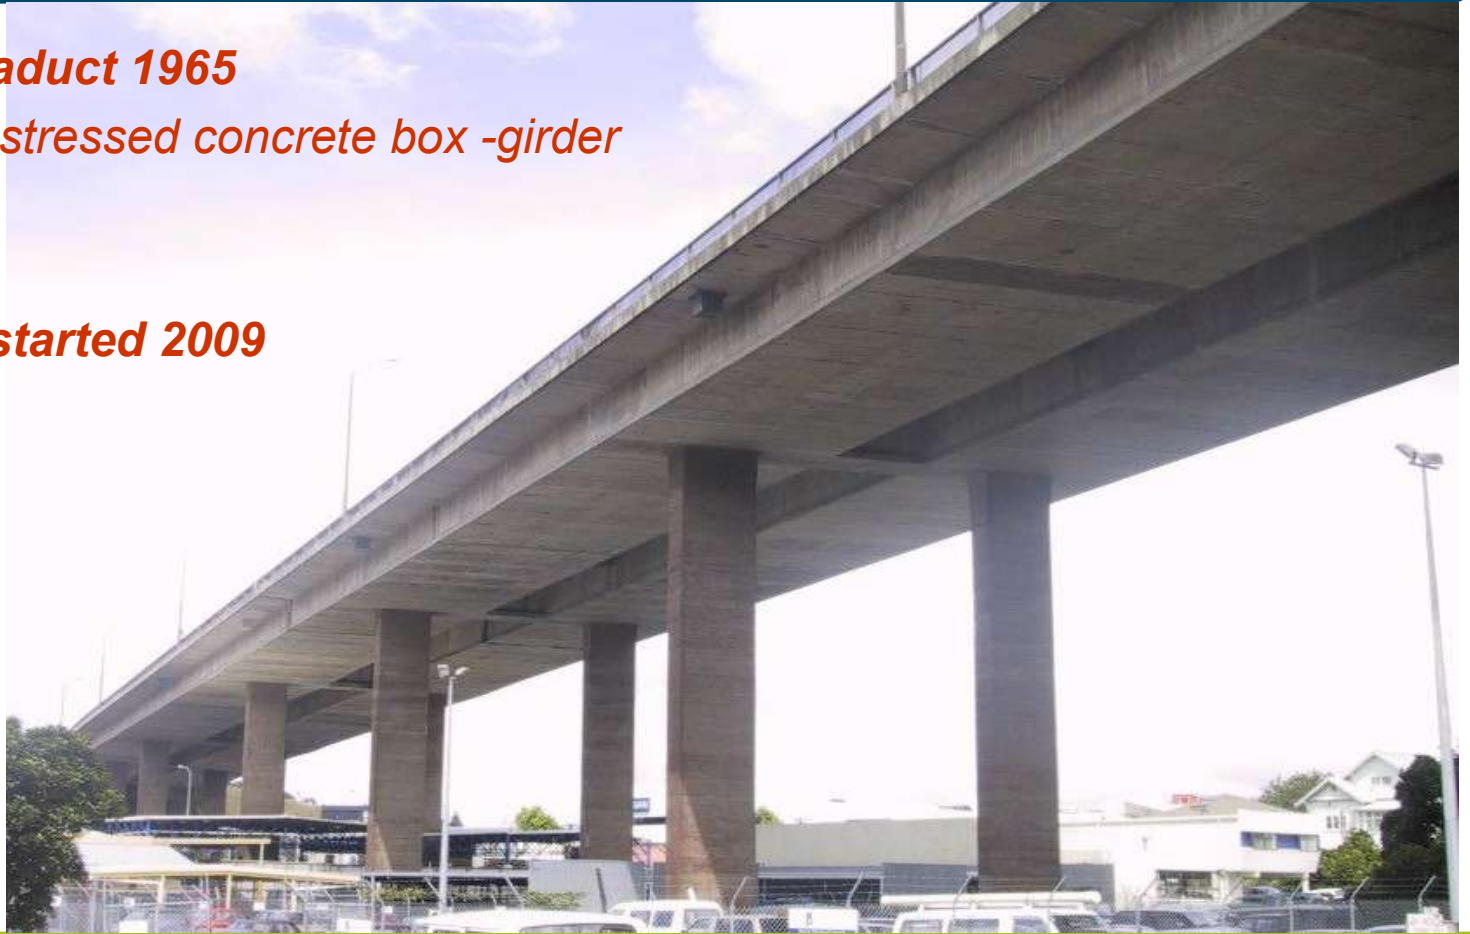
***Newmarket Viaduct 1965***

***Continuous prestressed concrete box -girder***

***Replacement started 2009***
