#### Bridge Owners Forum – 13<sup>th</sup> June 2023

#### **Eastham Bridge, Tenbury Wells**

Eastham Bridge Collapse Investigation & Findings

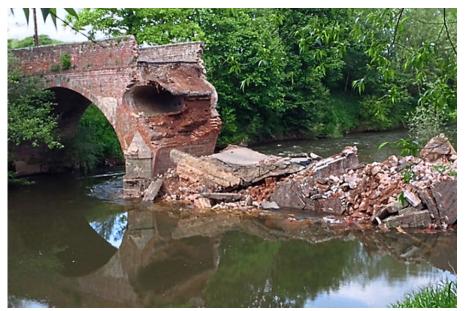
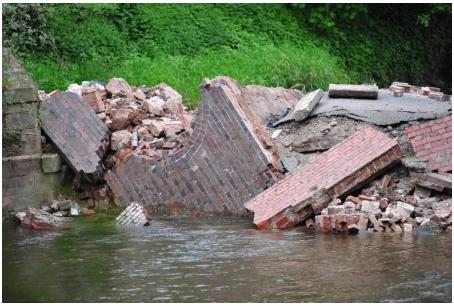
# Eastham Bridge Collapse 24 May 2016

There was nothing to suggest that the structure had become unstable during the flood events; the cracks in the parapet which have been attributed to previous movement of the south pier appeared stable. A road survey a month prior to the collapse indicated no disruption of the carriageway. It is difficult to identify any feature that could have indicated in advance that the structure had become unsafe.

The underlying cause of the collapse of Eastham Bridge is considered most likely due to scour of the south pier irrespective of road traffic. At this stage nothing has been identified that the collapse could have been predicted within the current inspection regime.

- Inspection Regime. Increase frequency of diving inspections. Currently annual, instead do them after every flood event
- WCC to consider adopting BICS
- Manual on scour at bridges and other hydraulic structures' Publication 551,
   CIRIA, 2002 consider its recommendations
- A review of other structures is suggested
- Extensive list of potential scour monitoring techniques

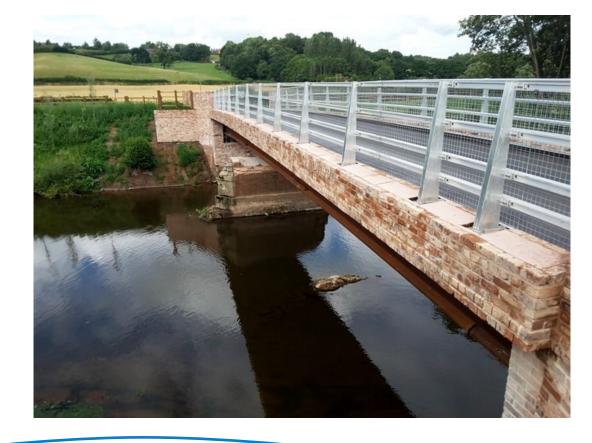
# Eastham Bridge re-build

- The bridge reopened to traffic in April 2017 and construction fully completed in September 2017.
- Weathering steel composite, 33m span on piled foundations
- 12,500 bricks from the old structure used as cladding for the new bridge
- The very first vehicle to drive across the bridge was the Lindridge First School minibus, driven by Derek Trow
