Flexural Retrofitting of Concrete Bridge Beams Using CFRP Fabrics

Huy Pham and Riadh Al-Mahaidi

Department of Civil Engineering, Monash University, Melbourne

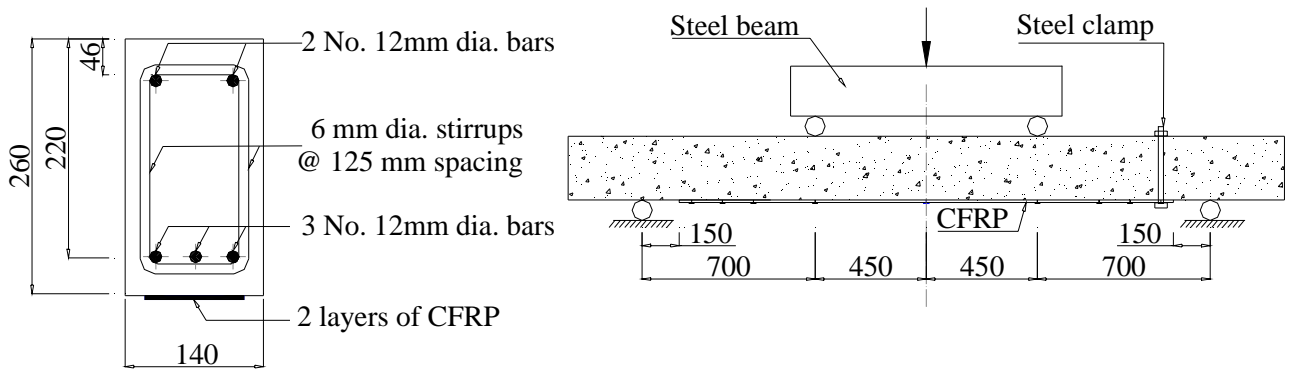
Figure 1: Typical beam dimensions (Beam S1)

A total of eight RC beams were constructed. Two were control beams and six were retrofitted with two plies of carbon fibre reinforced fabrics (CFRP) 1000 mm long and 100 mm wide. All of the beams were tested in four-point bending with the span of 2300 mm and the shear span of 700 mm. Two identical beams were manufactured for each configuration (Beam a and b). Three configurations were labelled S1, S2 and S3. The reinforcement for S1 is shown in Figure 1. For a parametric study, the stirrup spacing in S2 was reduced to 90 mm and the tension reinforcement in S3 included only 2 N12 bars.

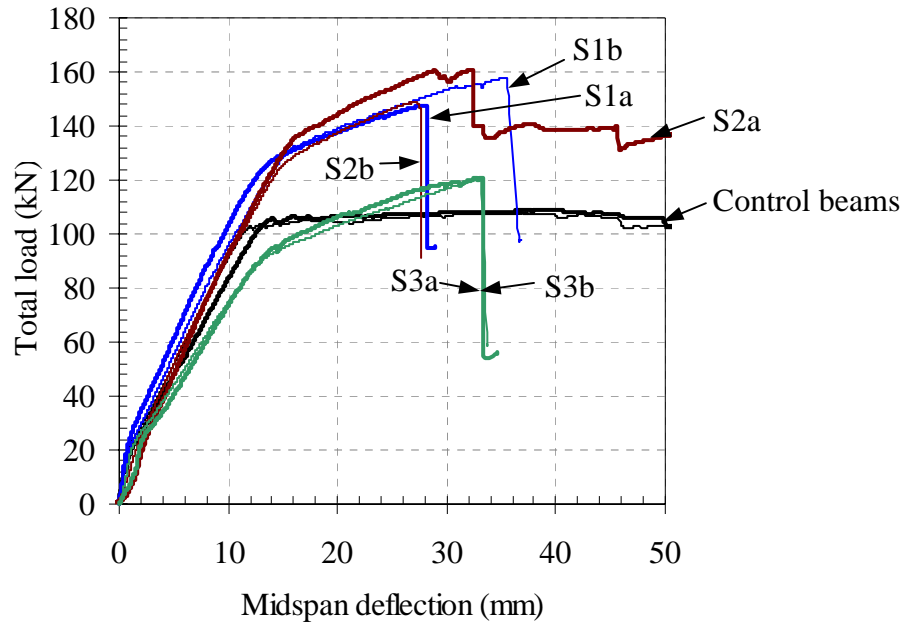
Figure 2: Loading curves

All strengthened beams failed by steel yielding followed by debonding of CFRP. The load deflection responses for the beams are plotted in Figure 2. Three regions can be clearly identified corresponding to when the concrete is not cracked, when the concrete is cracked and when the steel reinforcement yields. As expected, after the yielding of steel, major increase in tension was transferred to FRP.

Beams S3a and S3b had less tension reinforcement, which was indicated by the lower stiffness as in Figure 2. Beam S3a failed by mid-span debond first appeared on the clamped side. S3b failed by combination of mid-span and end debond on the unclamped side.

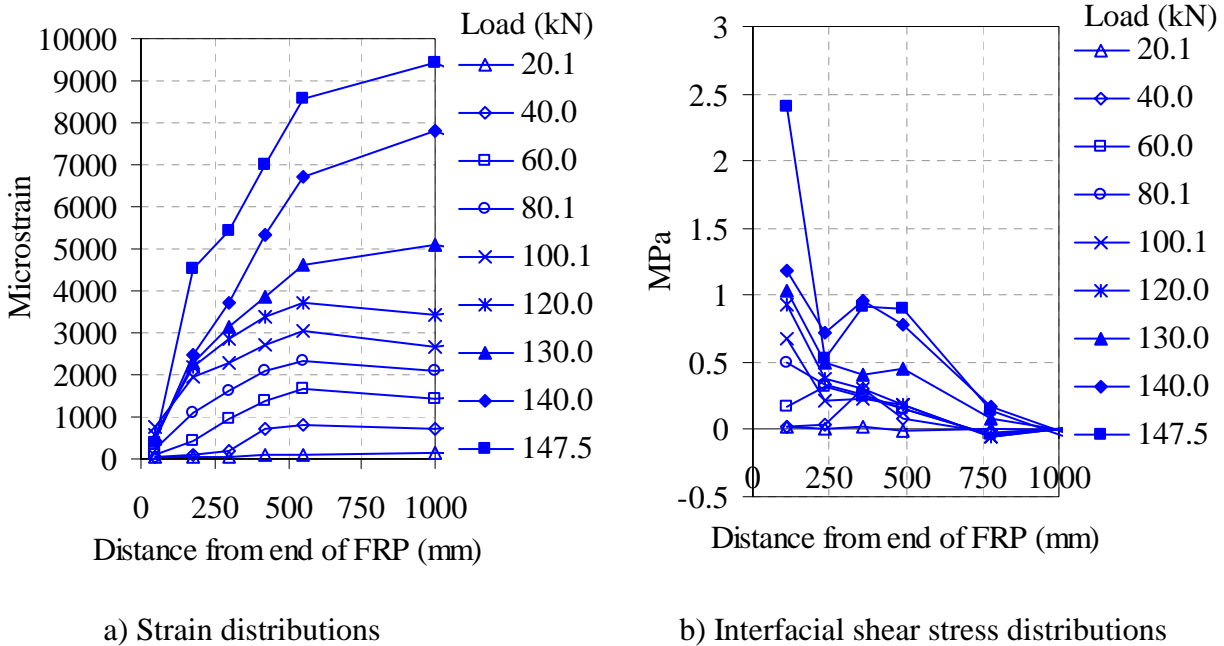
Figure 3: Strain and shear stress distributions at different load levels

The variations in longitudinal strain and bond stress in CFRP at different load levels for S1a are plotted in Figure 3. The strain drops from the maximum value under the load point to zero at the end of the plate. The stress is derived from the FRP strain distribution. The stress distributions for all six retrofitted beams indicate that delamination generally occurs at a shear stress level around 0.85 MPa.

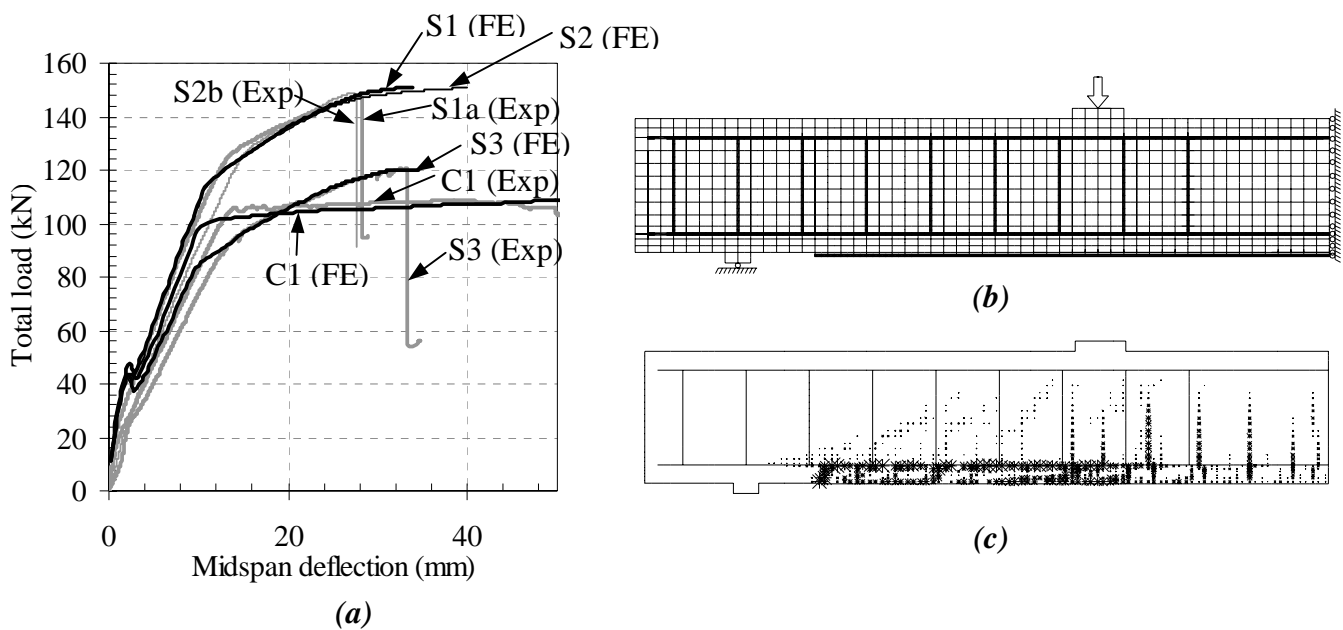
Figure 4: FE analysis: (a) Loading curves; (b) Mesh and boundary condition; (c) Crack patterns

The load versus midspan deflection curves from numerical models are compared with the corresponding experimental ones in Figure 4a. The curves match well for all three distinct regions: concrete uncracked, concrete cracked and steel yielding. The predicted ultimate loads predicted by FE models are very close to the experimental results.

Similar crack development was observed in FE models (Figure 4c). At first, flexural cracks appeared near mid-span. As loading was increased, inclined flexural shear cracks could be seen in the shear span. Debond cracks were visible after steel had yielded. They opened wider as load was increased more. Shear cracks extended to the load point were also seen but these cracks did not open wider due to the presence of the stirrups. As the load level was close to the ultimate value, the curve started to level off. The slip of the concrete cover below tension reinforcement due to high axial stress in FRP could then be seen in the model. It represented debonding type of failure. Due to the nature of smeared crack models, the curve descended gradually instead of experiencing a sudden drop.

DIANA 8, a versatile FEA package, was used in this study. Plane stress elements with 20 x 20 mm mesh were used. The FRP was modelled using beam elements assuming perfectly elastic up to rupture. Line reinforcements were used. They were connected to concrete through interface elements. Plasticity for reinforcement was based on the Von Mises yield criterion. Eight-noded quadrilateral isoparametric elements were used to model concrete. The concrete width near tension reinforcement level was reduced according to the amount of reinforcement present (Figure 4b).

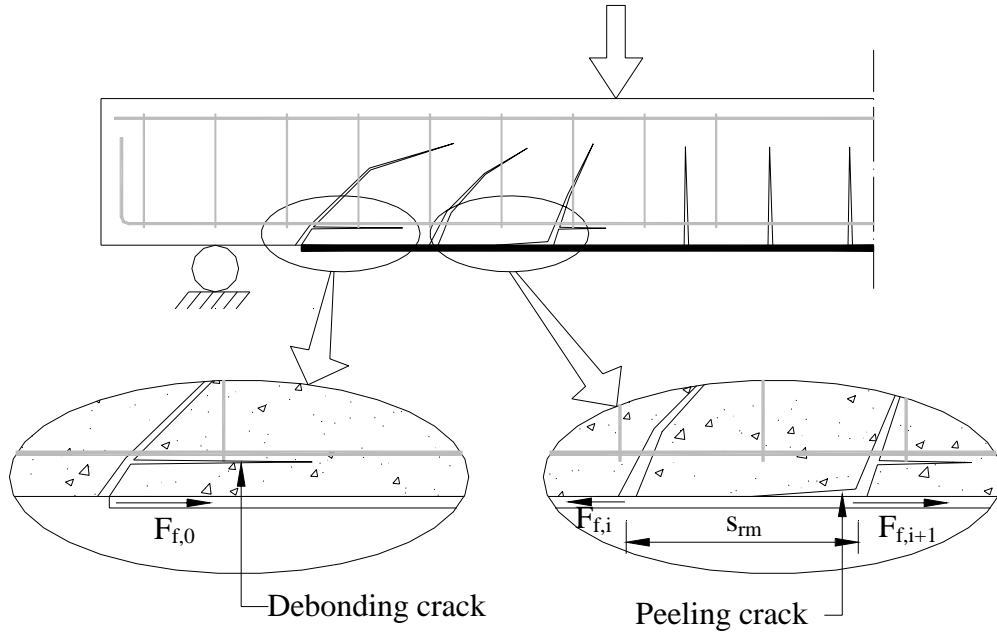
Figure 5: Failure mechanisms

Figure 5 explains the failure mechanisms of the two types of debonding. End debond is the result of the tensile force $F_{f,0}$ pulling on the end of FRP. This leads to a high shear stress level at the weakest layer near tension reinforcement level, inducing a longitudinal debonding crack there. For mid-span

debond, the situation is different. The concrete tooth between two adjacent flexure-shear cracks is subjected to a tensile force, which is the difference between $F_{f,i}$ and $F_{f,i+1}$. The pulling force $F_{f,i+1} - F_{f,i}$ causes the peeling crack. Once this peeling crack propagates, tension is transferred to the concrete tooth on the right side of the shear crack. That causes progressive delamination towards the centre of the beam.

Based on the observation of the failure mechanisms above, it is proposed that the debond capacity of retrofitted beams are controlled by two failure criteria. End debond occurs when the force $F_{f,0}$ is large enough so that the shear stress at the concrete layer near tension reinforcement exceeds the concrete shear strength. Mid-span occurs when the force difference $F_{f,i+1} - F_{f,i}$ is large enough to cause peeling of FRP from concrete. The later situation is similar to a simple shear test, in which FRP is bonded on a concrete block and pulled on one end until failure.

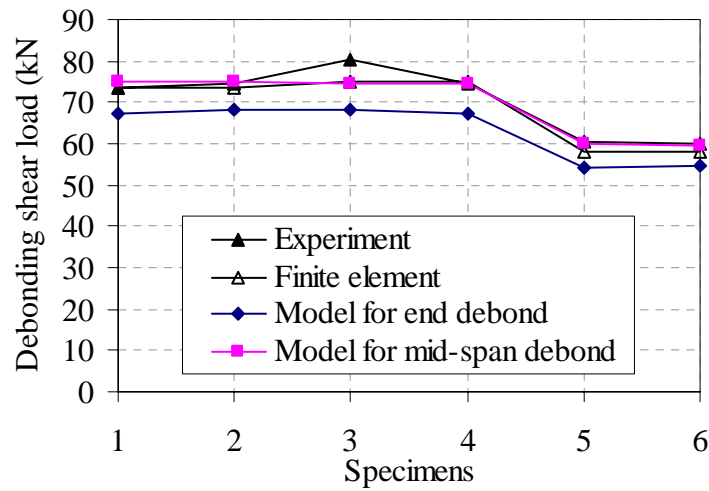
Figure 6: Comparison between the theoretical models and experimental results

As shown in Figure 7, the two models proposed above predict the failure loads for those beams accurately. As expected, the model of end debond gives a slightly conservative results.

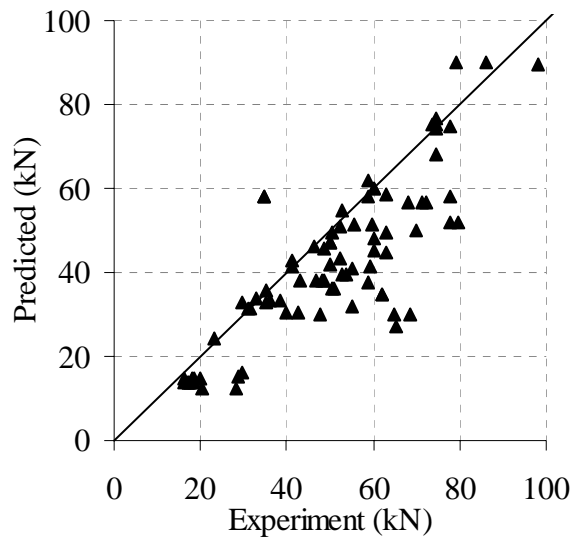
Figure 7: Verification of the proposed models

The proposed theoretical model was also verified with the beams listed in Table 1. The result is shown in Figure 8. For the beams failed by end debond, the average predicted failure loads are 80% of the experimental results. For the beams failed by mid-span debond, the ratio of predicted value to the actual results is 1.03.
