North West Flooding 22/23 August 2017 What happened?

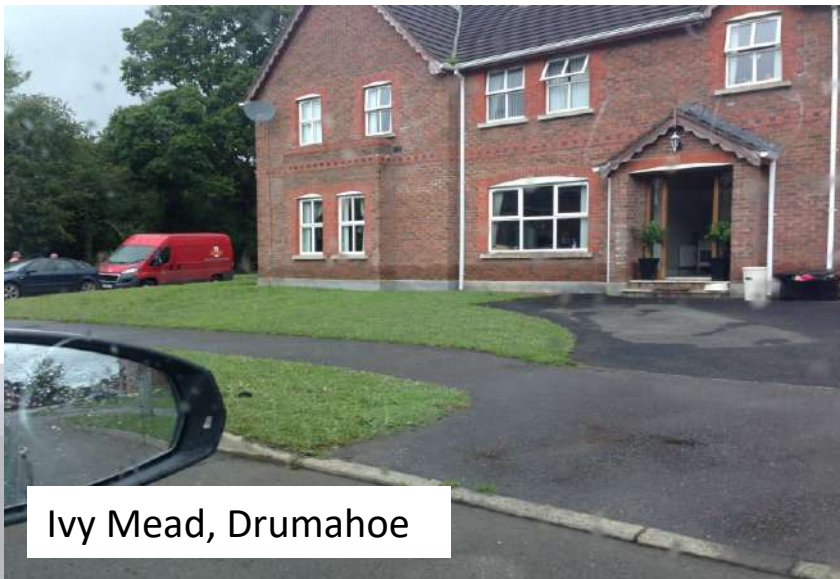
Ivy Mead, Drumahoe

- Approximately 400 domestic properties flooded
- Approximately 35 Businesses flooded
- Various Community facilities impacted

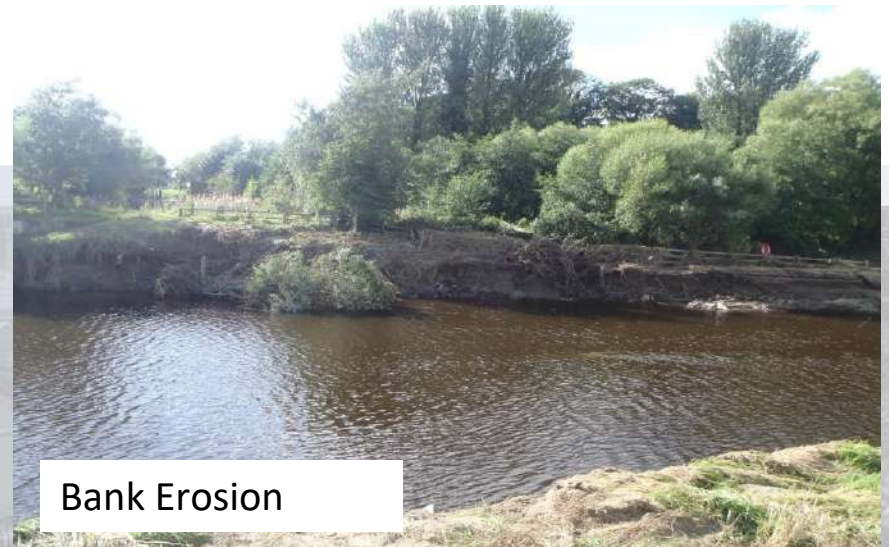
Bank Erosion
